DRAFT Environmental Assessment

Tazewell County Public Service Authority Capital Improvements Plan - Phase 2 Tazewell County, Virginia

April 2020

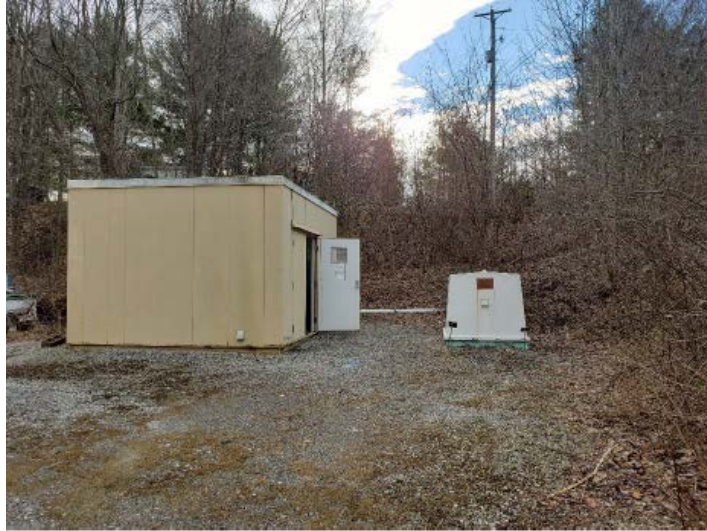
Photograph 1. TCPSA Dailey's Chapel Pump Station

One of the pump stations to be rehabilitated – the Dailey's Chapel pump station – is shown in Photograph 1. The Panther Branch Pump Station No. 1, Coaldan Pump Station No. 1, Cavitt's Creek Pump Station, and College Estates Pump Station look similar to the Dailey's Chapel pump station.

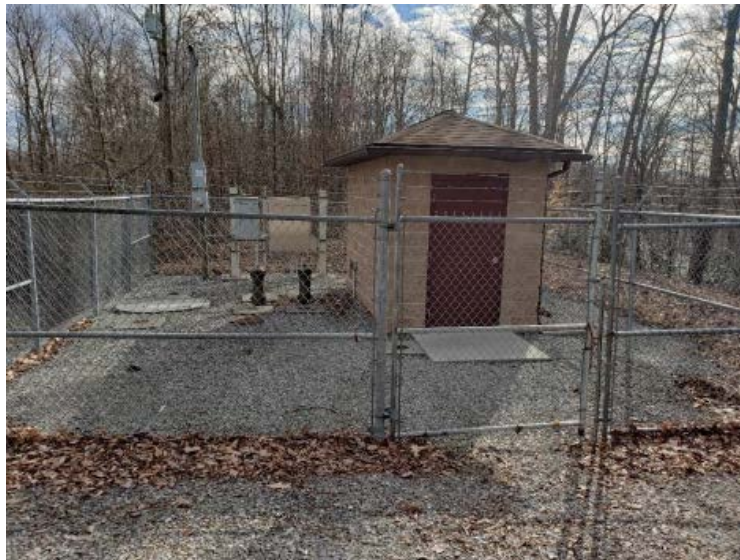
Photograph 2. TCPSA Panther Branch Pump Station No. 3

Two of the pump stations to be rehabilitated, Panther Branch Pump Station No. 2 and No. 3, are submersible pump stations like that shown in Photograph 2.

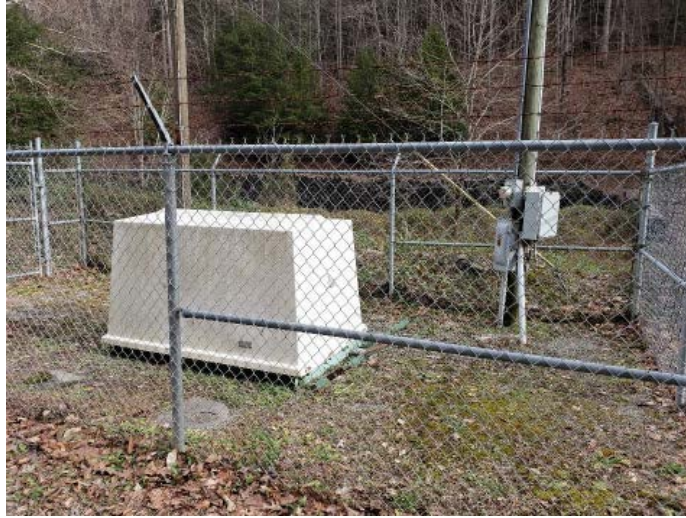
Photograph 3. Coal dan Pump Station No. 2

The final pump station, Coaldan Pump Station No. 2, is located in an insulated enclosure shown in Photograph 3.

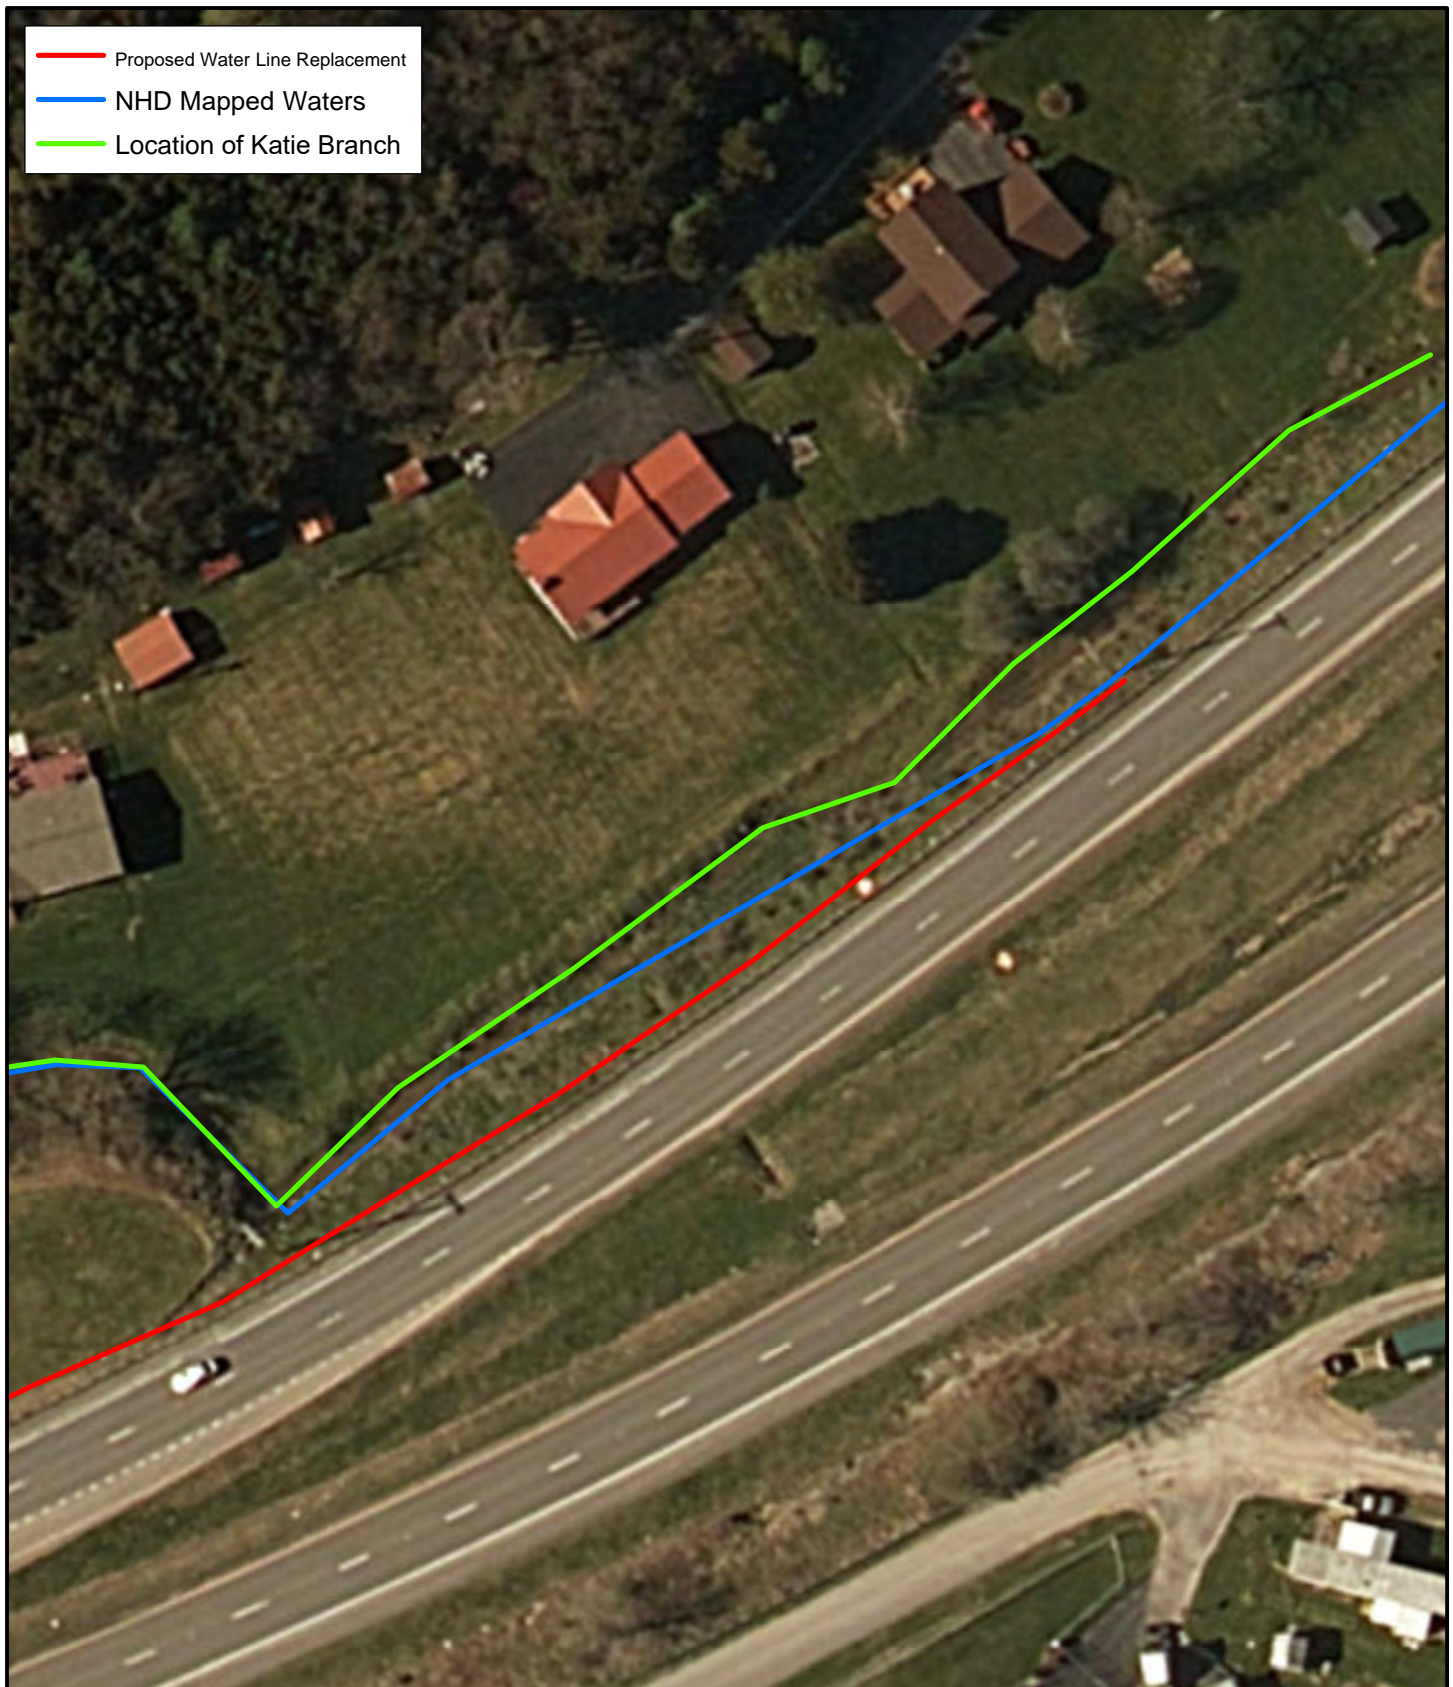
FIGURE 4
WESTERN WATER LINE REPLACEMENT
AREA WITH NHD DATASET
TCPSA DRINKING WATER CAPITAL
IMPROVEMENTS PLAN PHASE II
0 100 200
Feet
Tazewell, VA

- Proposed Water Line Replacement
- NHD Mapped Waters
- Location of Katie Branch

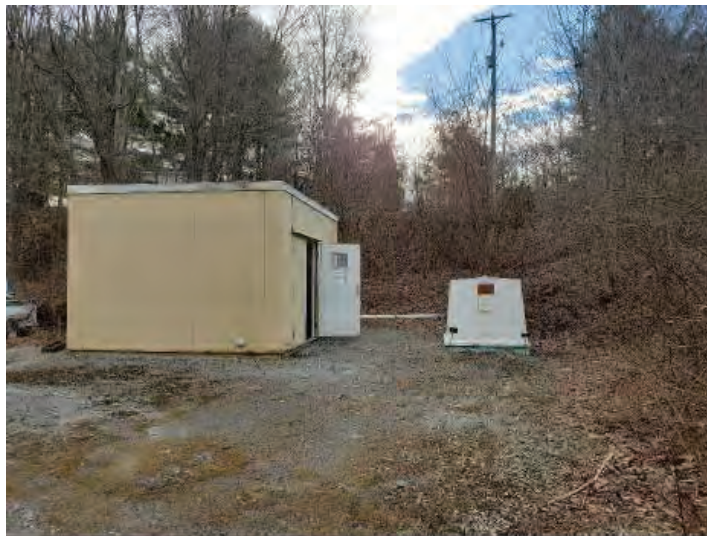
Photograph 1. TCPSA Dailey's Chapel Pump Station

One of the pump stations to be rehabilitated – the Dailey's Chapel pump station – is shown in Photograph 1 below. The following four stations look similar to the Dailey's Chapel pump station: Panther Branch Pump Station No. 1, Coaldan Pump Station No. 1, Cavitt's Creek Pump Station, and College Estates Pump Station.

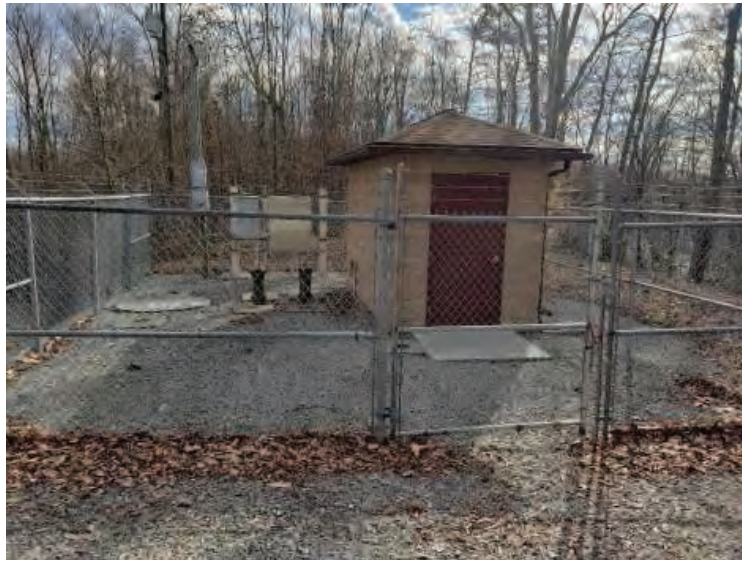
Photograph 2. TCPSA Panther Branch Pump Station No. 3

Two of the pump stations to be rehabilitated, Panther Branch Pump Station No. 2 and No. 3, are submersible pump stations like that shown in Photograph 2.

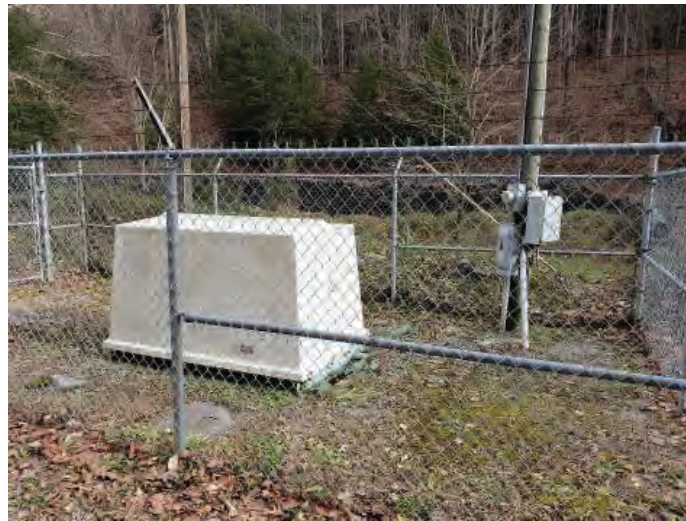
Photograph 3. Coaldan Pump Station No. 2

The final pump station, Coaldan Pump Station No. 2, is located in an insulated enclosure shown in Photograph 3.

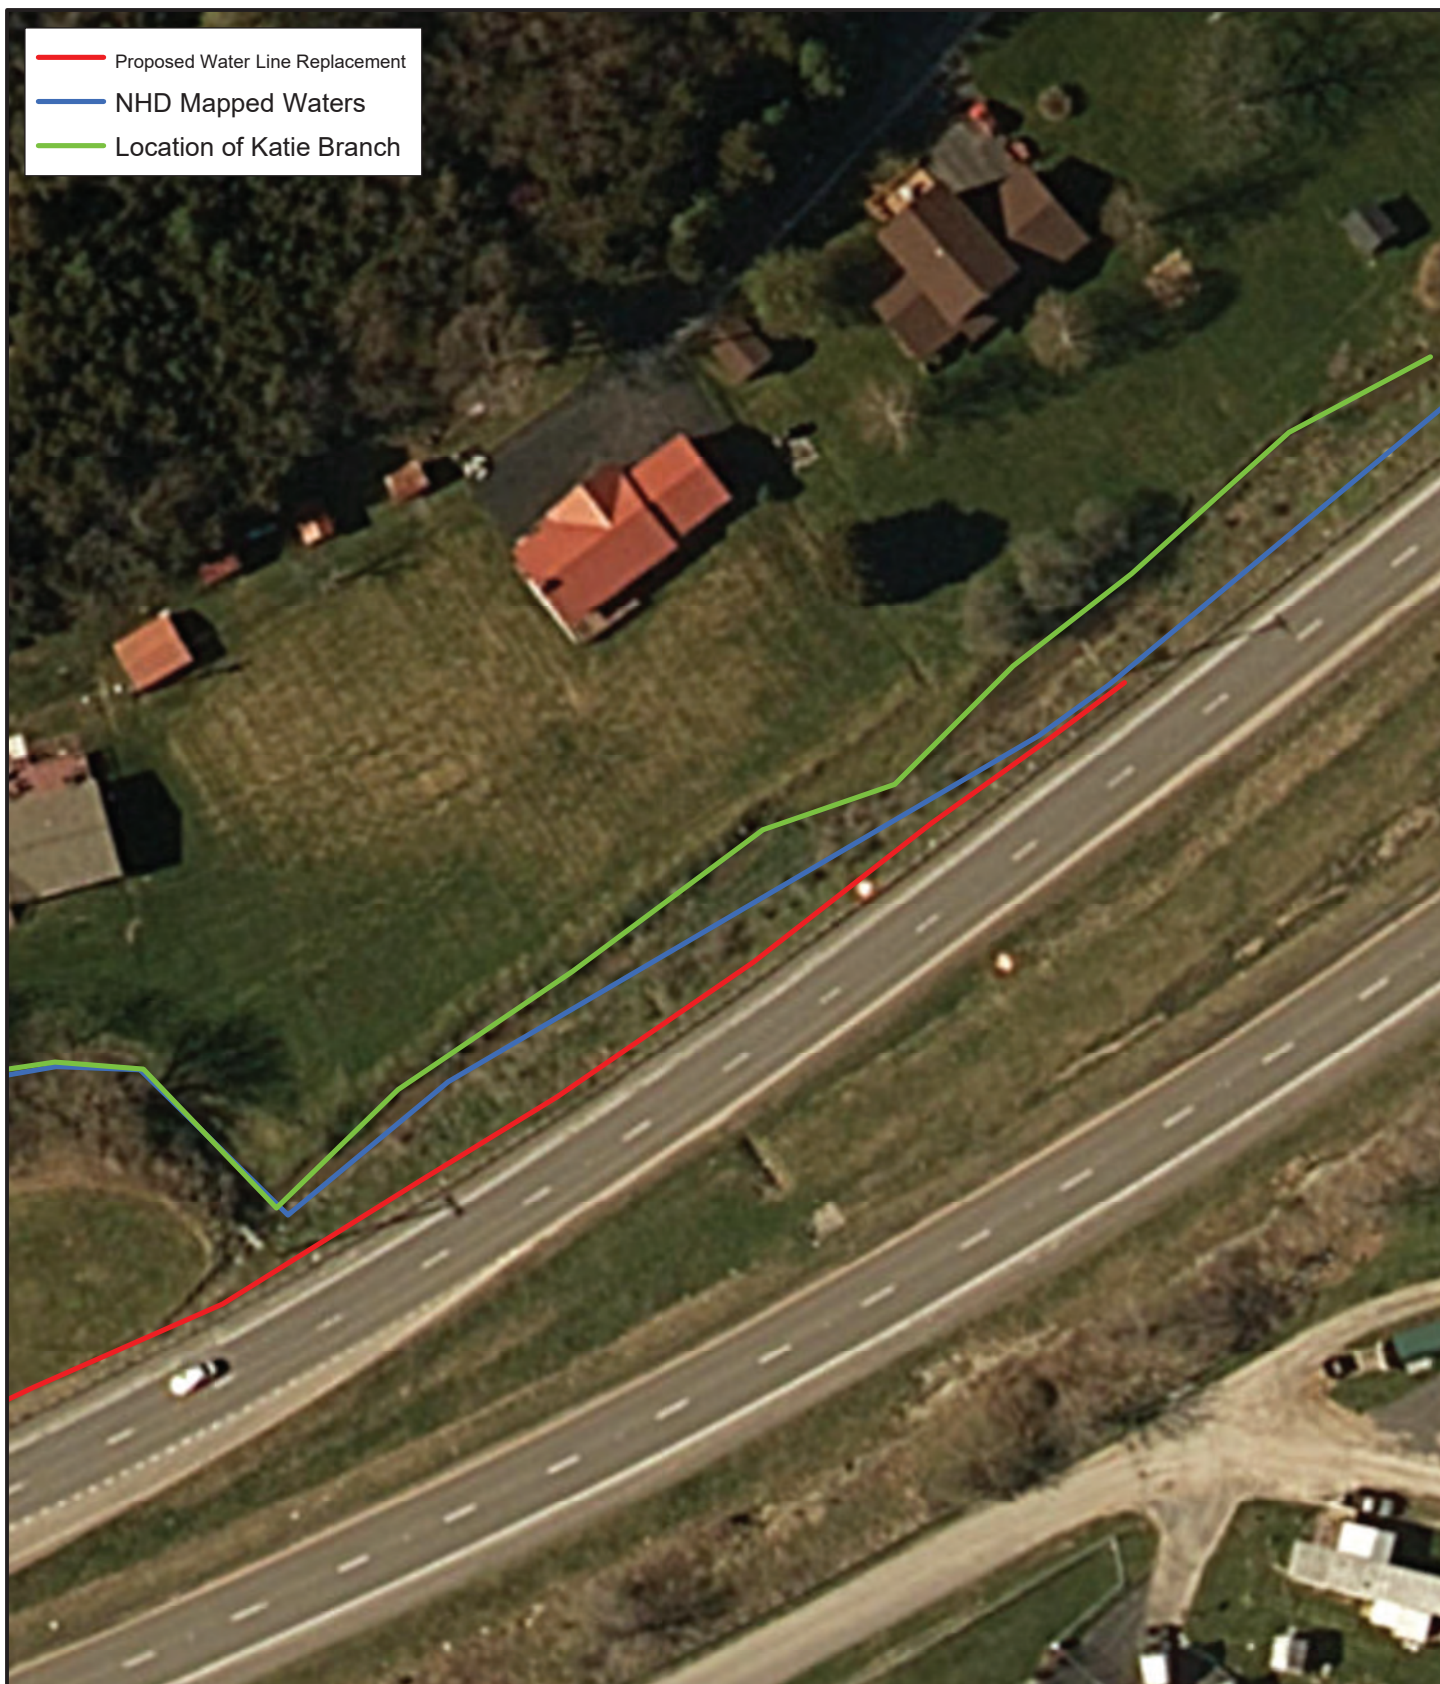
FIGURE 6
WESTERN WATER LINE REPLACEMENT
AREA WITH NHD DATASET
TCPSA DRINKING WATER CAPITAL
IMPROVEMENTS PLAN PHASE II

Katie Branch, a tributary to Little River, is near the proposed water line replacement project area, as identified by the National Hydrographic Dataset and shown on **Figure 5**. However, the National Hydrographic Dataset does not accurately depict the location of the Katie Branch channel. **Figures 6 and 7** show the actual location of Katie Branch where the channel is within close proximity (approximately 25 to 50 feet) of the proposed water line replacement. According to the National Wetlands Inventory 2016 Dataset, no wetlands are located near the proposed water line replacement (**Figure 5**). According to FEMA floodplain information, no portion of the waterline replacement lies in a floodplain (**Figure 8**).

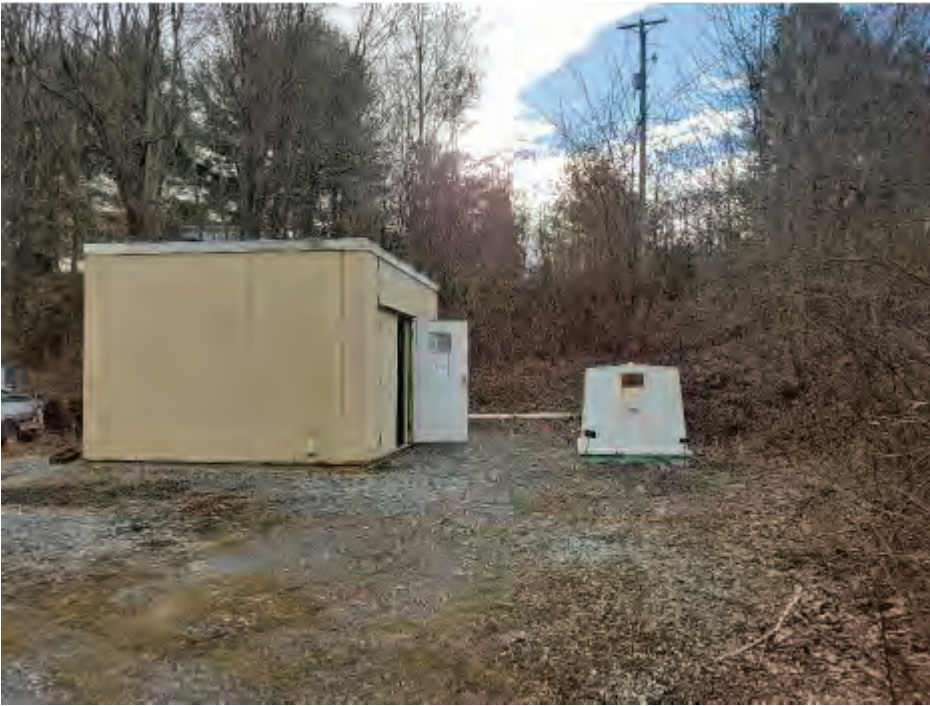
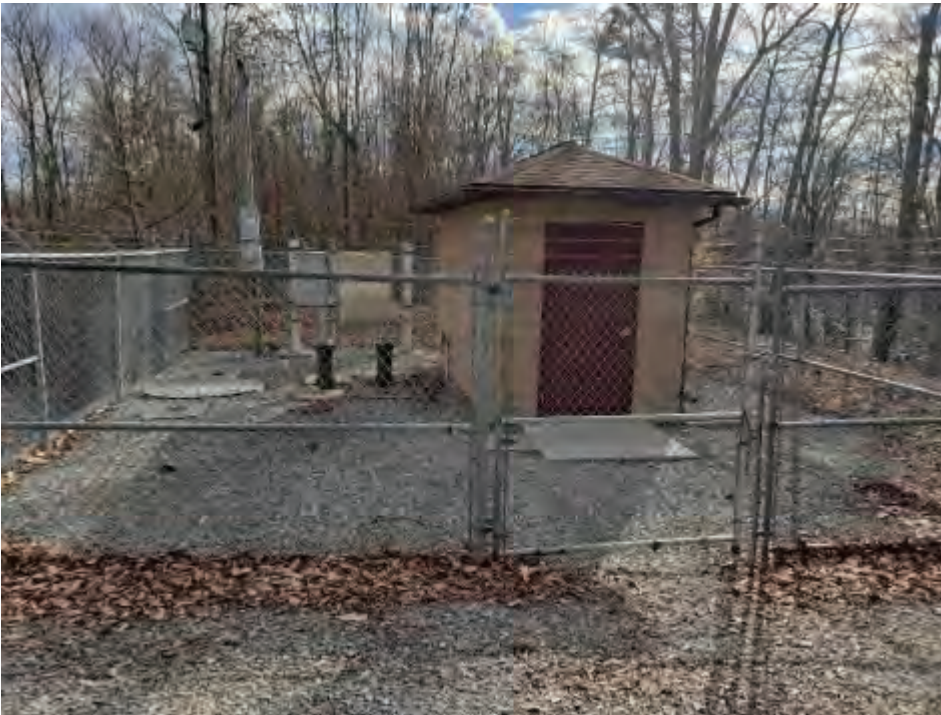
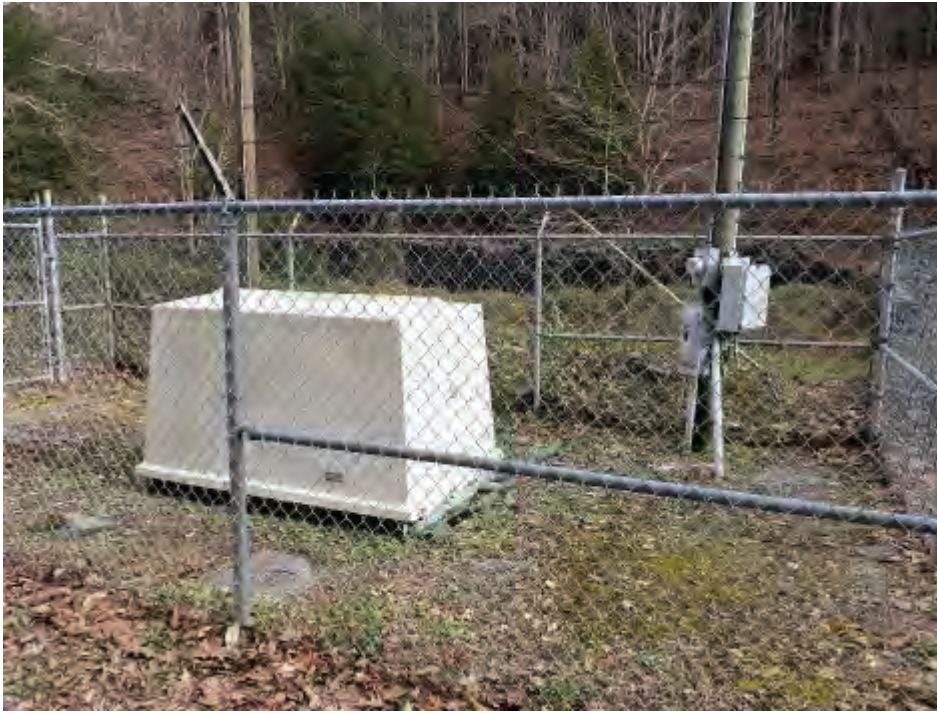
Here are photos of a few of the pump stations being rehabilitated. All work will occur on previously disturbed areas such as the gravel areas shown. TCPSA is planning to install a concrete pad on which to place a generator. Fencing will be added where there is none, or existing fencing expanded to include the generator area.

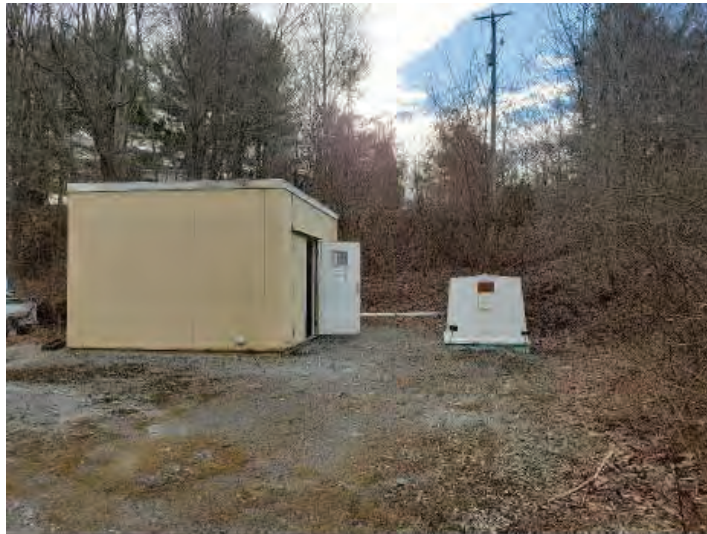
Photograph 1. TCPSA Dailey's Chapel Pump Station

One of the pump stations to be rehabilitated – the Dailey's Chapel pump station – is shown in Photograph 1 below. The following four stations look similar to the Dailey's Chapel pump station: Panther Branch Pump Station No. 1, Coaldan Pump Station No. 1, Cavitt's Creek Pump Station, and College Estates Pump Station.

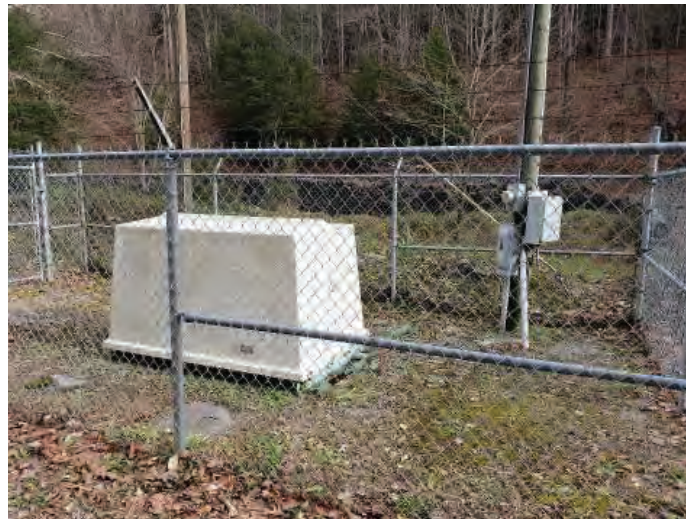
Photograph 3. Coaldan Pump Station No. 2

The final pump station, Coaldan Pump Station No. 2, is located in an insulated enclosure shown in Photograph 3.

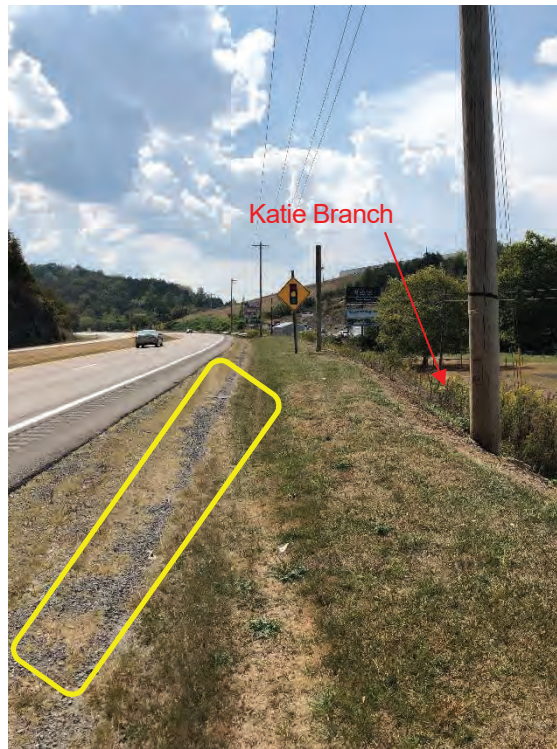
Photograph 4. Water line installation area (yellow) on edge of paved shoulder

- Off the edged of the paved shoulder, where there are no obstructions such as guardrail and electrical poles (**Photographs 4 and 5**)
- At guardrail locations, it will be installed on the backside of guardrail where there are no obstructions such as electrical poles (**Photographs 6 and 7**)
- Where there are guardrail or electrical pole obstructions, it will be installed in the paved shoulder (**Photograph 8**)

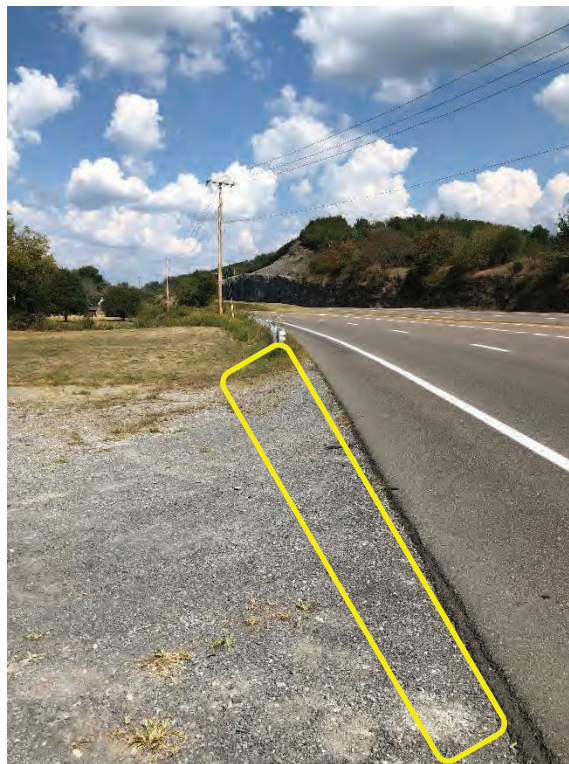
Photograph 5. Water line installation area (yellow) on edge of paved shoulder

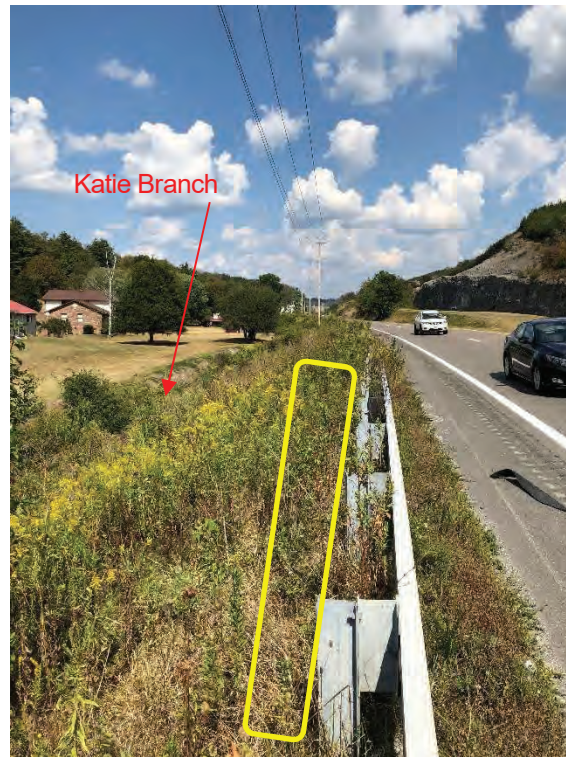
Photograph 6. Water line installation are (yellow) on backside of guardrail

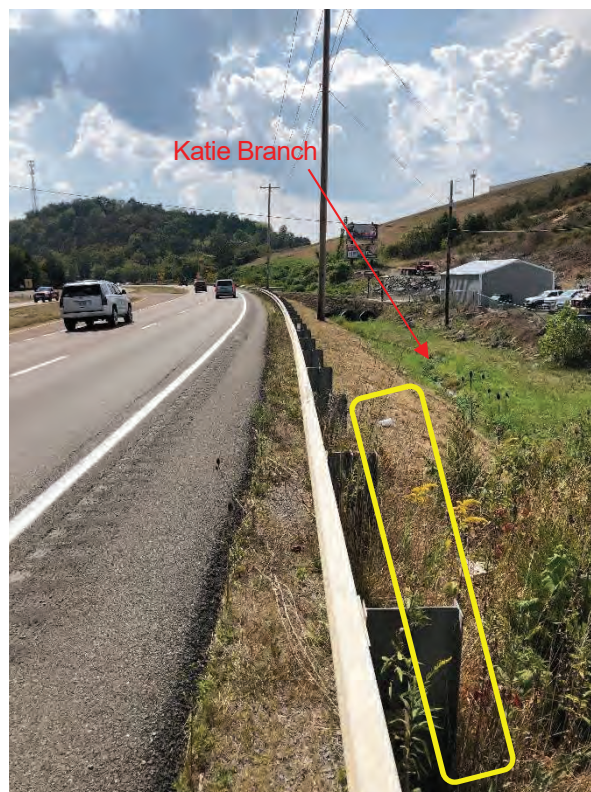
Photograph 7. Water line installation area (yellow) on backside of guardrail
